SWEPOS GNSS SIGNAL DISTURBANCE MONITORING

NKG working group for GNSS positioning
March 04-05 2025, Helsinki, Finland

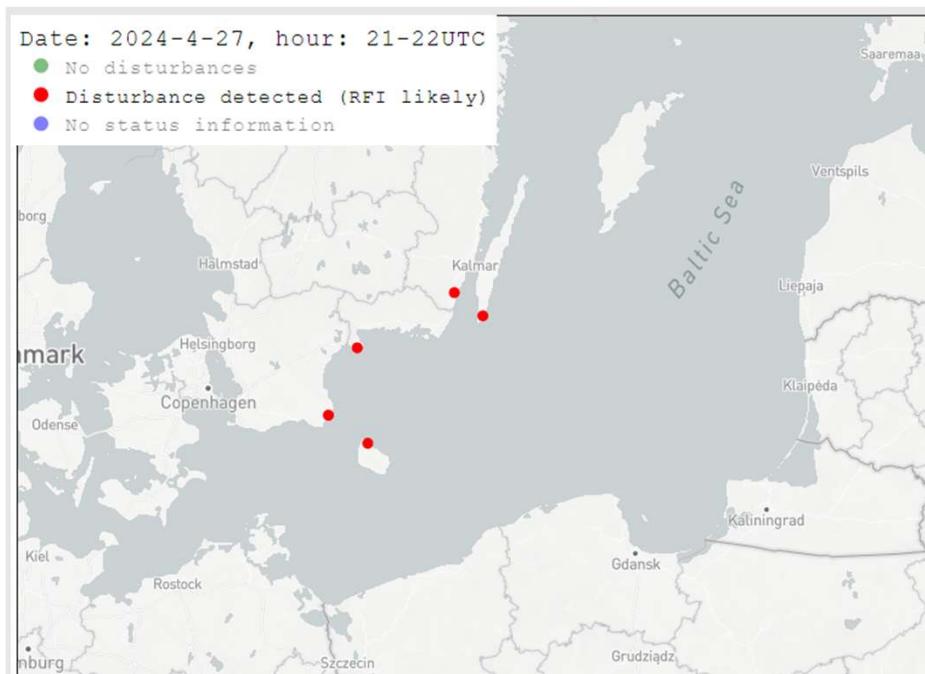
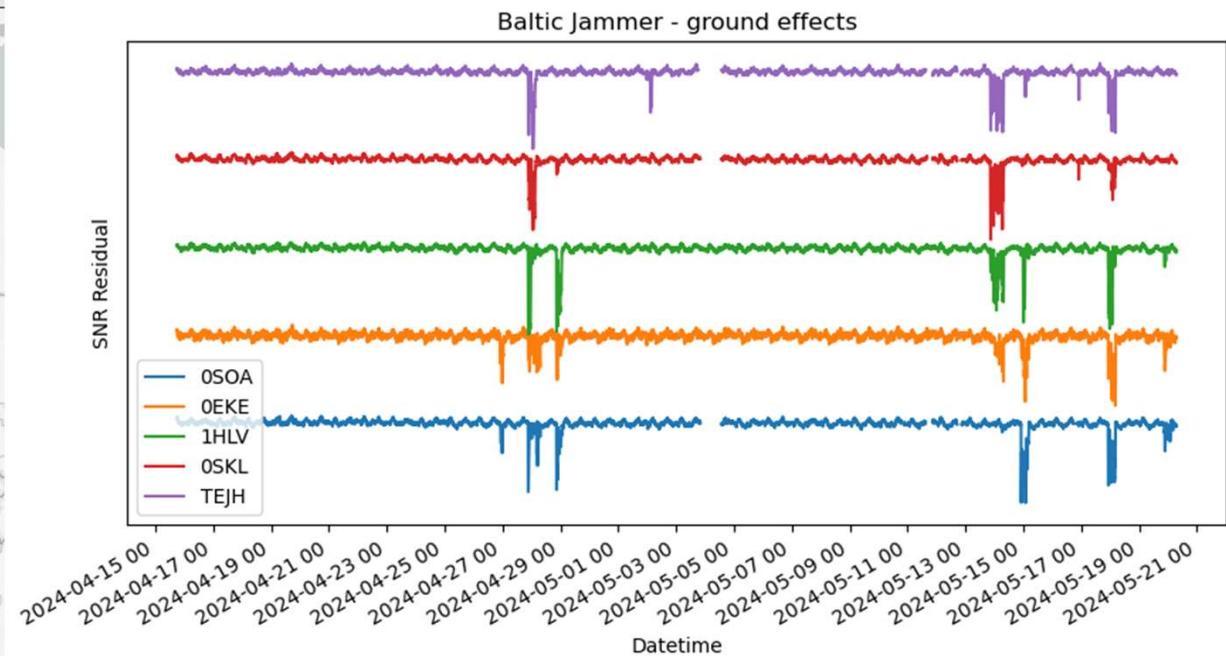
Baltic jammer – ground effects

- Affects LI band
- Interference central frequencies: 1561, 1575 och 1603 MHz

- First recorded event: April 27, 2024
- Last recorded event: July 22, 2024

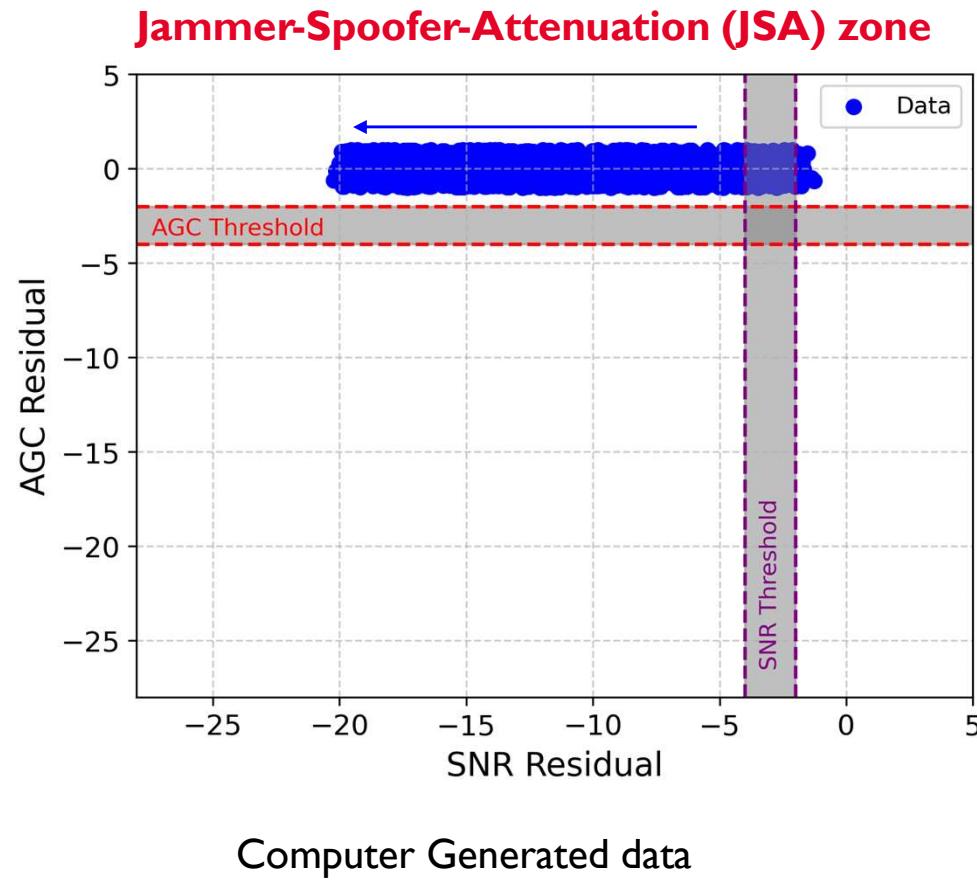
Combined AGC-SNR approach for GNSS signal interference detection

- Nominal
 - Interference free
- Jamming
 - SNR and AGC drops
- Spoofing
 - AGC drops
 - SNR increases or remains the same
- Signal attenuation – leads to poor signal
 - AGC remains the same
 - SNR may drop
 - **Signal attenuation**
 - Tree foliage, snow, ionospheric scintillations?
- Faulty equipment (e.g., Antenna/Splitter/Cable problems?)
 - Show different behavior

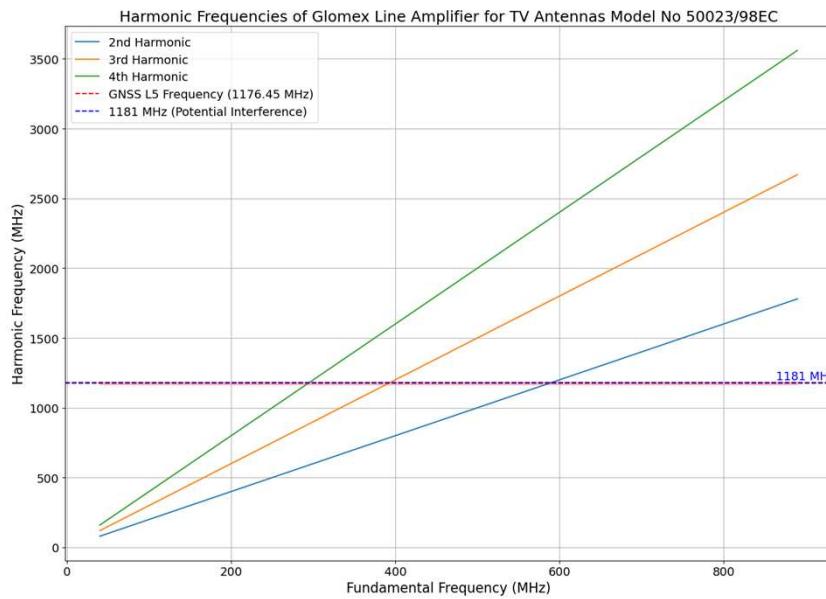
Source - TV antenna amplifier on a boat

- GLOMEX 50023/98EC amplifier
- Adjusts antenna gain
- Operating frequency far from GNSS – Harmonics is likely cause

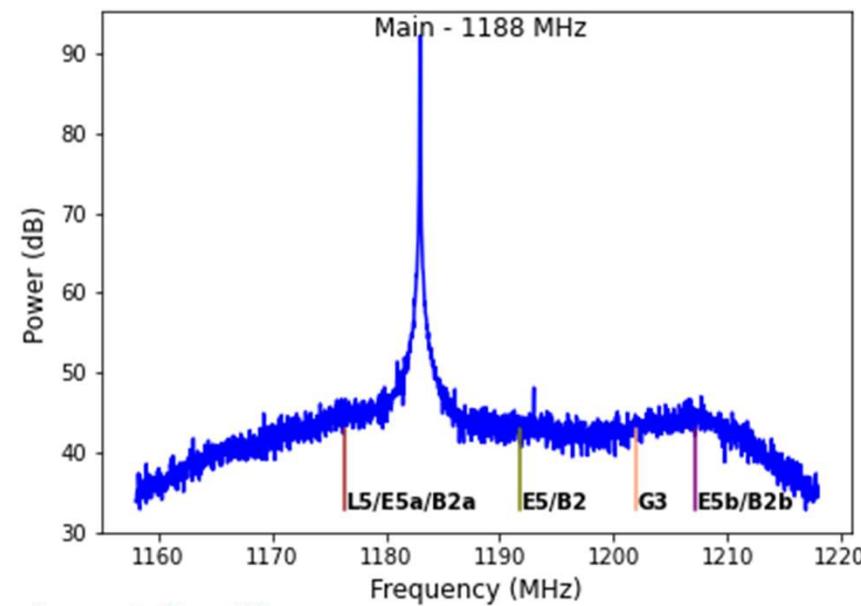
Effect – L5 band

- GPS, GAL, BDS affected
- RFI centered at 1181 (2nd harmonics of 590.5 MHz)

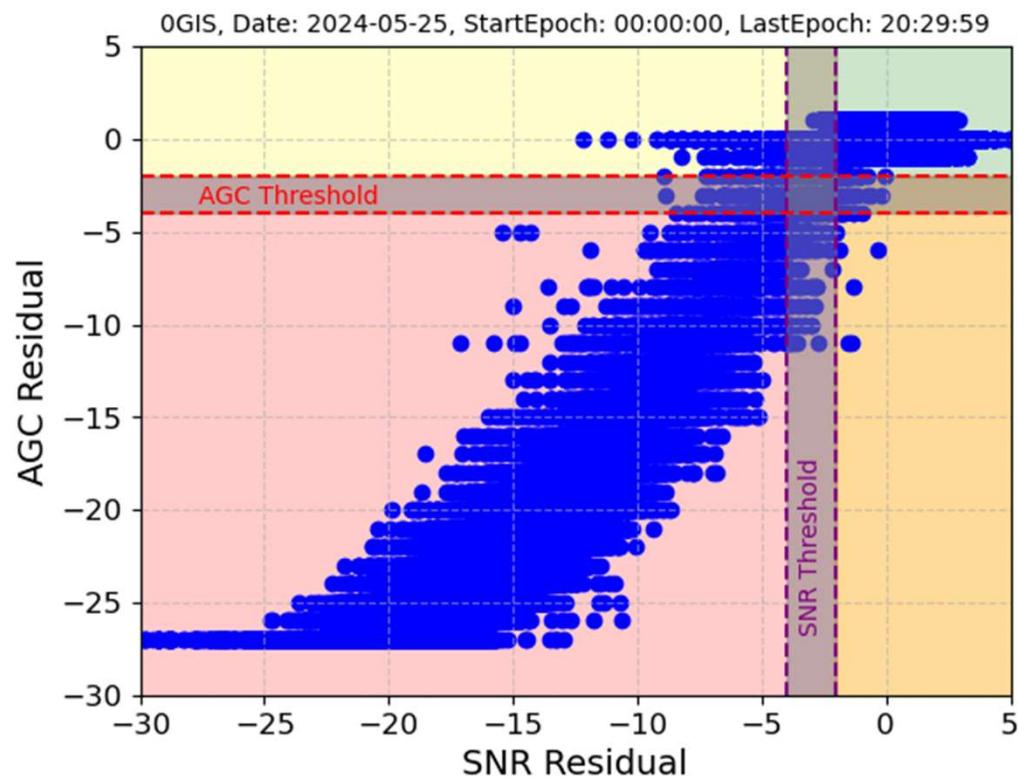
AGC-SNR combined approach

Actual disturbance at a SWEPOS station – 0GIS

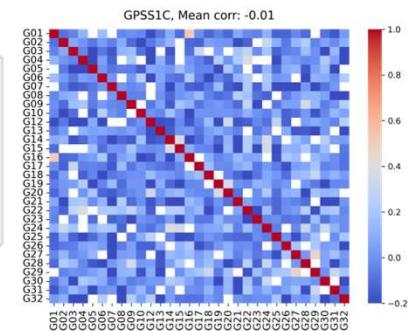
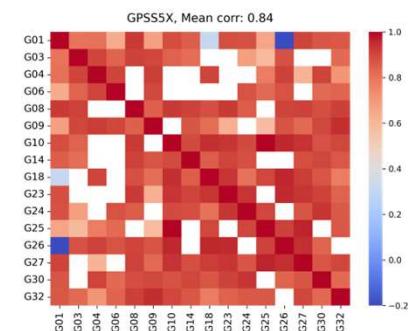
Disturbance Types

- No disturbance Zone
- Attenuation Zone
- Jammer Zone
- Spoofing Zone

SNR of the affected signal is correlated among satellites tracked simultaneously

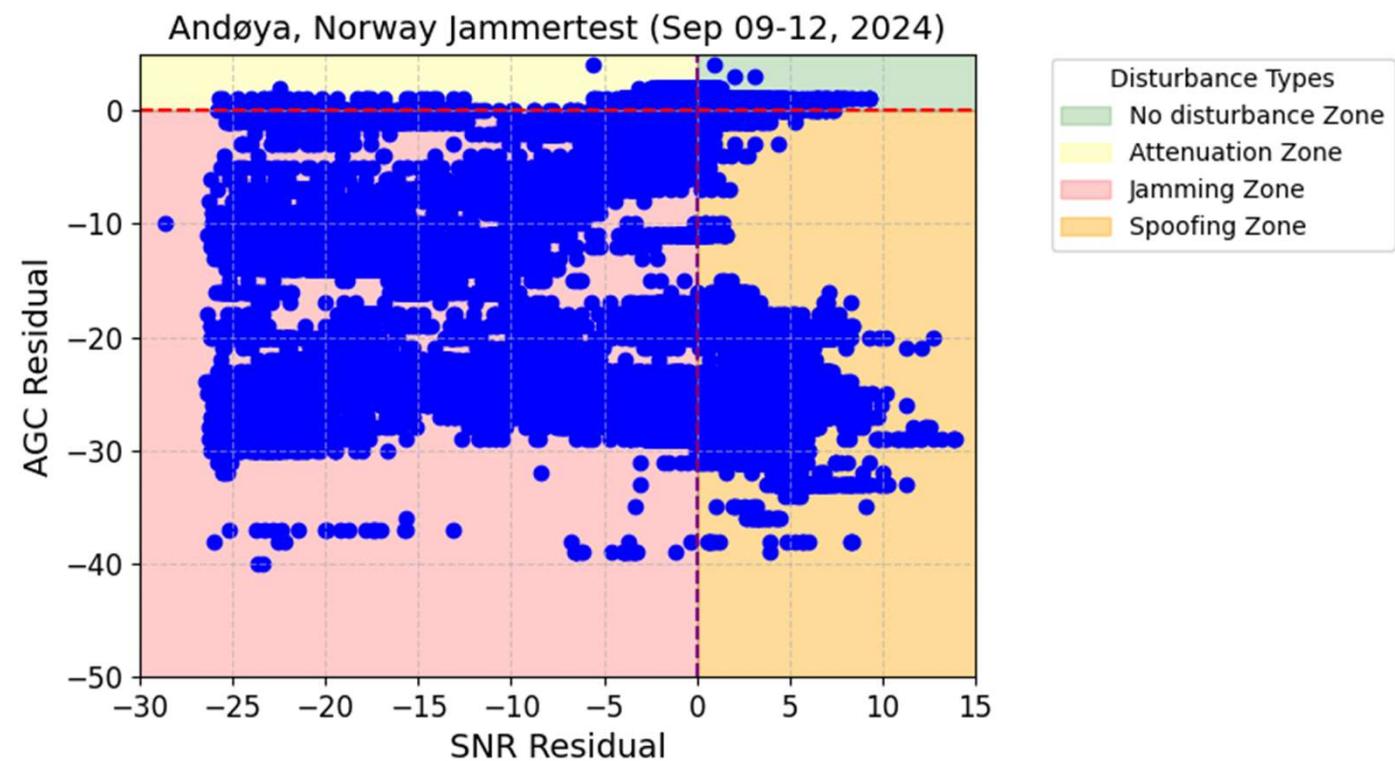
Actual disturbance – Andøya, Norway Jammer test 2024

- Data from NLS Finland
- Septentrio PolarX5
- Receiver mitigation on/off
- Data shown for GPS L1 only
- SNR and AGC nominals obtained from no interference periods

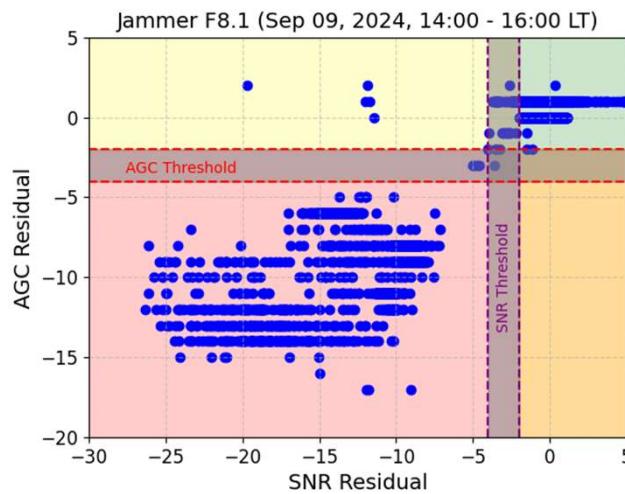
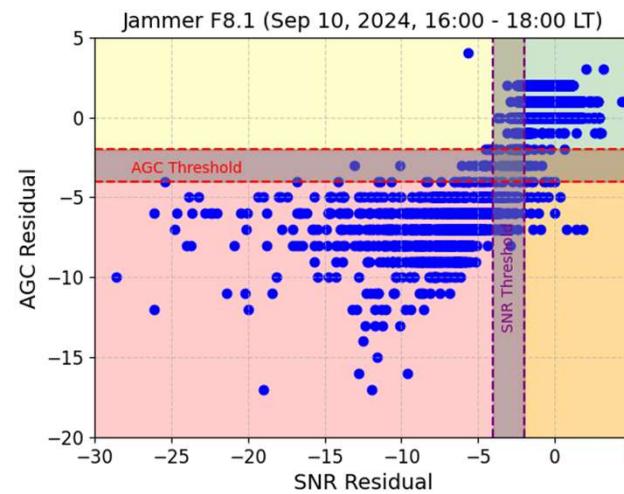
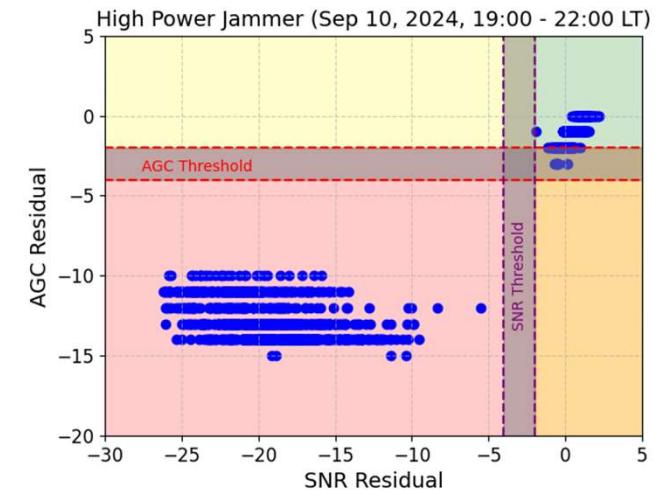
Jamming

- Jammer F8.1 "Porcus Major"
 - Power 50W
 - Sweep rate 100KHz
 - Test bands 'L1', 'E1', 'B1C', 'G1', 'L2', 'L5', 'E5a', 'B2a'

- Jammer F8.1 "Porcus Major"
 - Power 50W
 - 50 W frequency drift
 - Sweep time 1 minute
 - Test bands 'L1', 'E1', 'B1C', 'G1', 'L2', 'L5', 'E5a', 'B2a'

- High Power PRN jamming
 - Power 100W
 - Test bands 'L1', 'E1', 'B1C', 'G1', 'L2', 'L5', 'E5a', 'B2a'
 - Transmitter F8.1

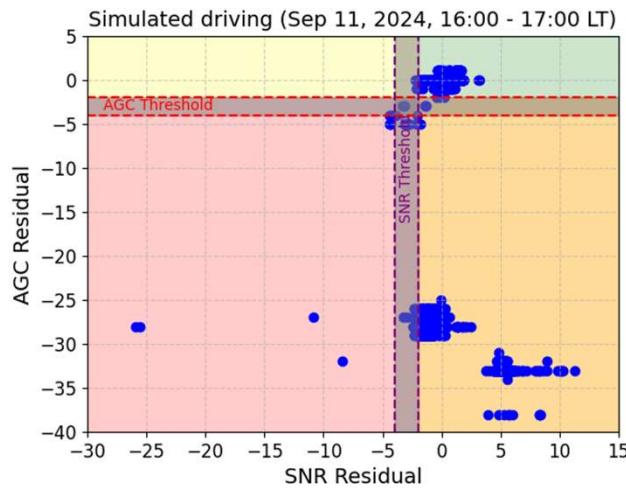
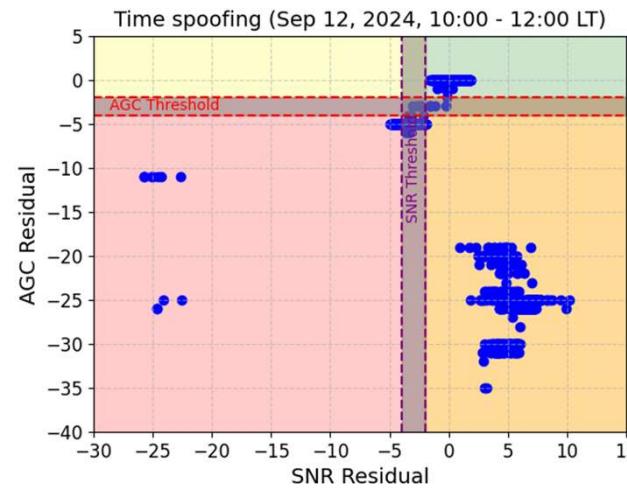
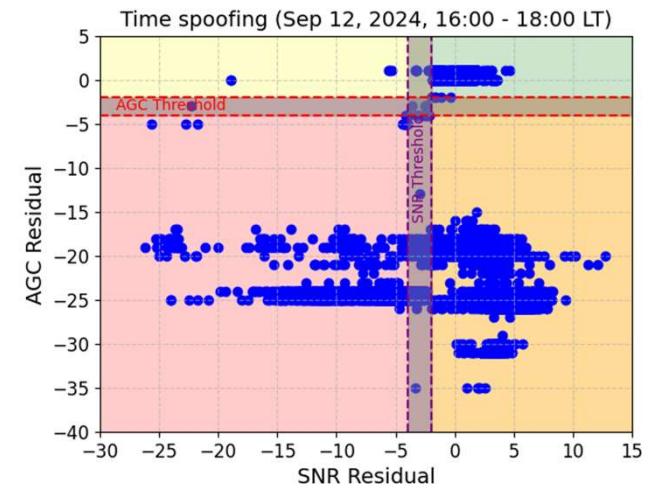
Spoofing

- Simulated driving (route I). GPS LI C/A and Galileo E1
 - Power 0.316 W
 - Initial jamming prior to spoofing
 - Equipment S

- Static + Pseudorange error. GPS LI only
 - No jamming
 - Initial jamming and continuous jamming
- Time offset
 - No jamming
 - Fixed spoofed position
 - Power ramp and jump

- Static + Pseudorange error, with initial and continuous jamming
- Static + UTC-parameter nav. Data manipulation (removing leap seconds)
 - Fixed spoofed position
 - Removing -145 leap seconds – spoofed signal says back in 2016

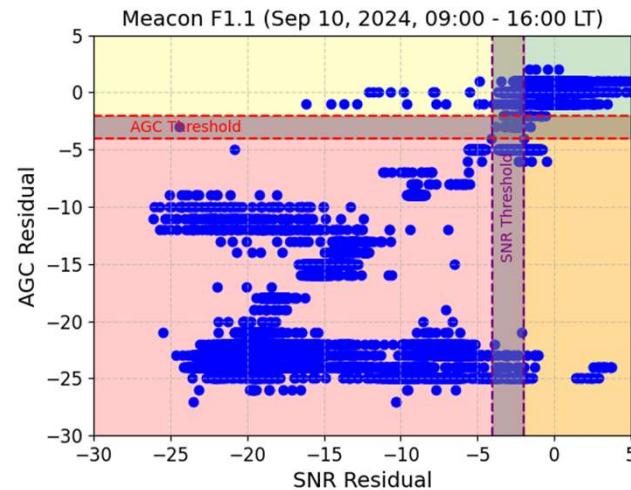
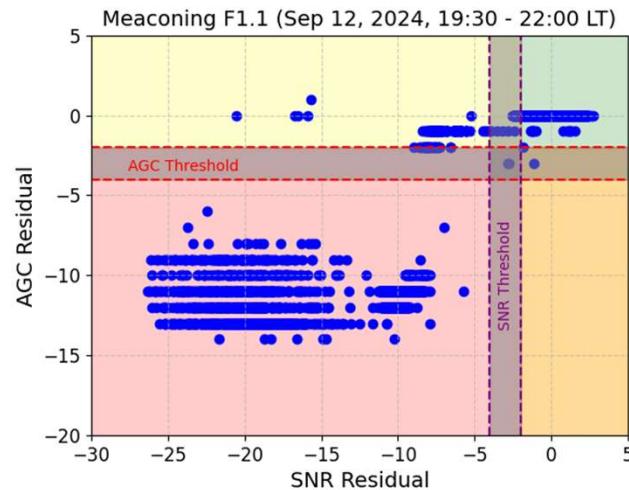
Meaconing

- Meacon F1.1 "Porcellus":
 - Several scenarios
 - The re-radiated is strong enough to cause AGC drops
 - Two copies of the same GNSS signal (direct, re-radiated) – as not time/phase aligned – can cause correlation degradation which leads to SNR drops
- Meacon F1.1 "Porcellus":
 - 10W meaconing from receiver RX1
 - Test bands 'L1', 'E1', 'B1C', 'L2'

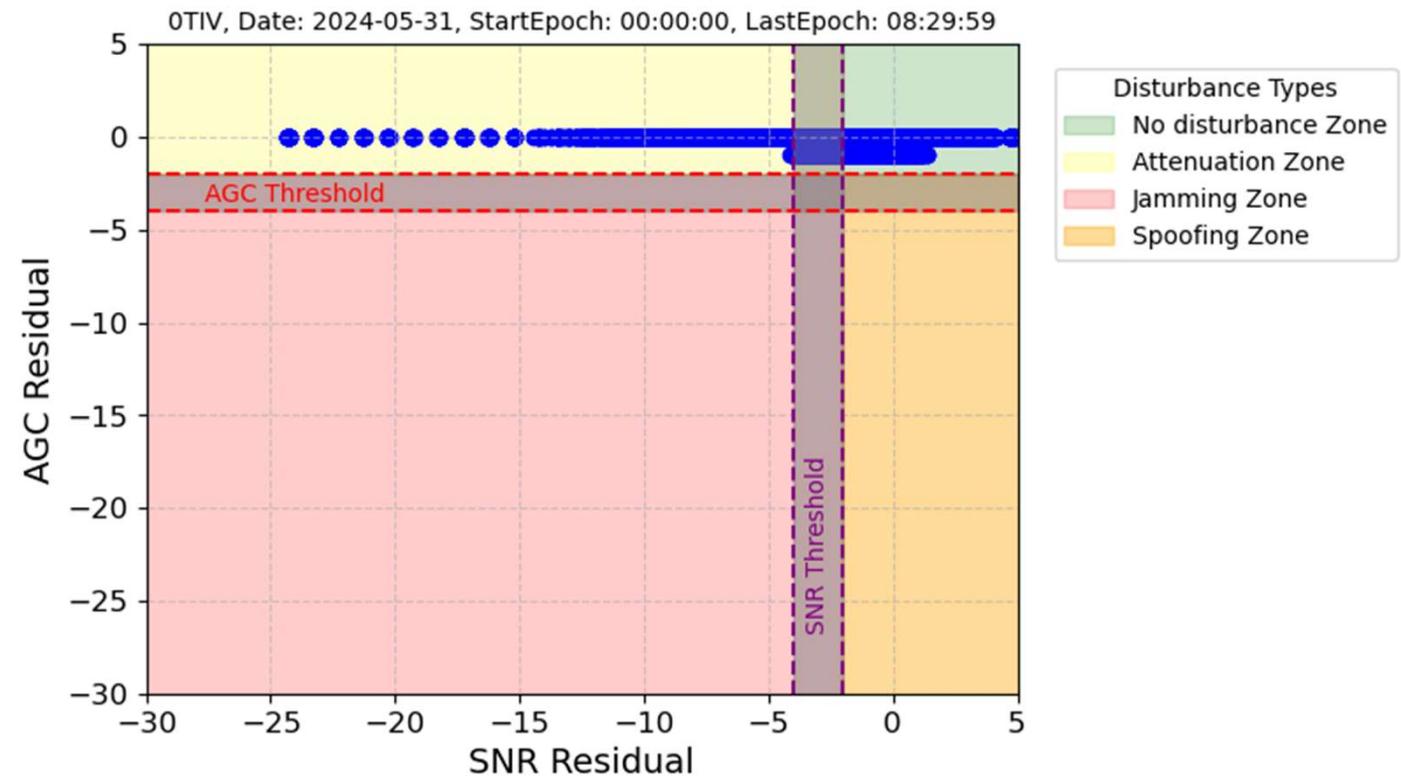
Effect – All bands

Actual disturbance at a SWEPOS station – 0TIV, type - Attenuation

Source – Large trees near by

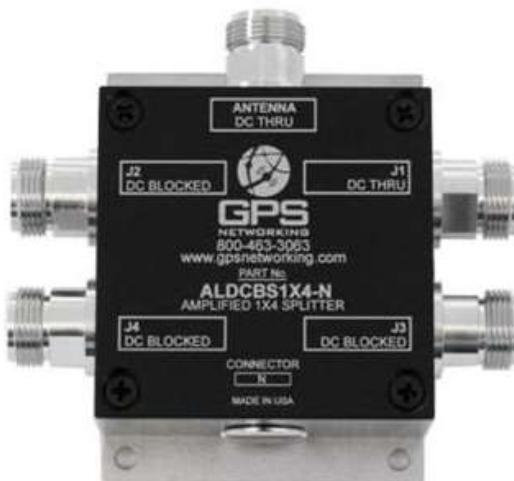
Source – Antenna splitter

- GPS Networking ALDCBS1X4-N amplifier
- Signal-amplified without external power supply
- Provides 18 dB amplification

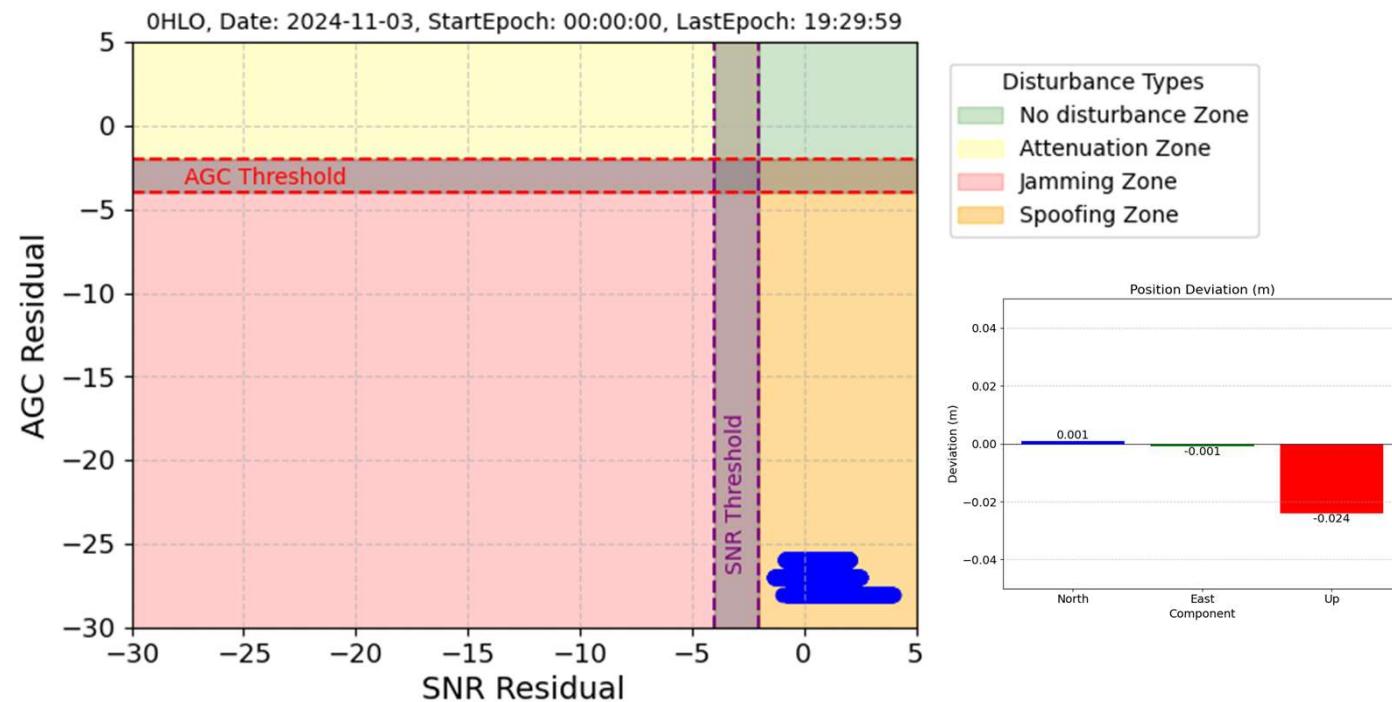
Effect – All bands

- AGC drops to avoid overloading the receiver front end because of amplified input
- SNR remains the same the amplified splitter increased both signal and noise levels proportionally

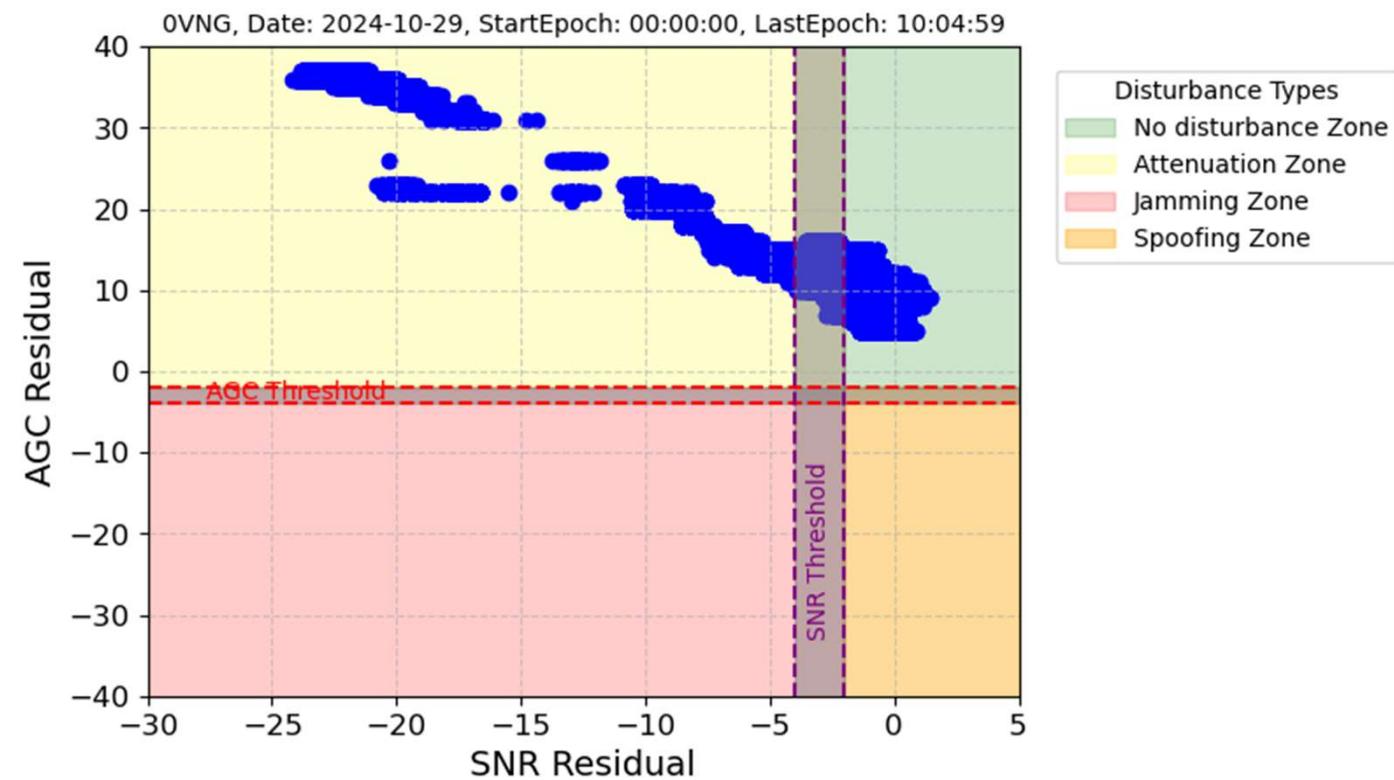
Effect – All bands

SNR drops, AGC increases – The system amplifies the signal to achieve adequate signal level
